Mercy Corps

Project Overview

*Mercy Corps Exterior West
Facade from Bridge - Photo
Credit: Jeff Amram*

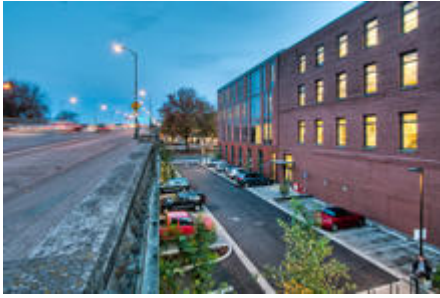
The small parking lot to the north is paved with pervious pavement to encourage direct ground infiltration during rainfall - Photo Credit: Jeff Amram

The building redeveloped a major brownfield and infill site in the city, densifying and reinforcing the urban fabric while protecting adjacent environments, which include a significant urban park and weekend public market. Full cut off downlights for site lighting reduce light pollution, and the small parking lot to the north is paved with pervious pavement to encourage direct ground infiltration during rainfall.

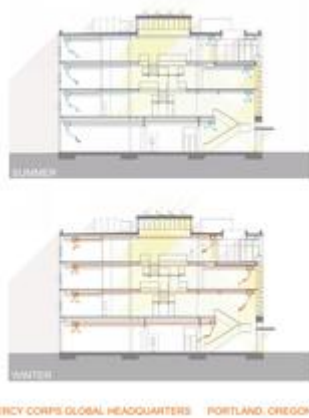
MERCY CORPS GLOBAL HEADQUARTERS PORTLAND, OREGON

*Mechanical Sections - Photo
Credit: THA Architecture*

The mechanical system was designed to be simple, decreasing operation and maintenance costs while operating efficiently and in conjunction with other strategies to reduce overall energy use. The grand staircase at the heart of the building acts as a ventilation stack, drawing air in and up through a monitor-controlled clerestory. Combined with operable windows, this strategy reduces any need to cool the building by drawing cool summer breezes from the north side to the south side of the building and stair stack. During the winter months, however, the north side of the building benefits from passive solar heat gain.

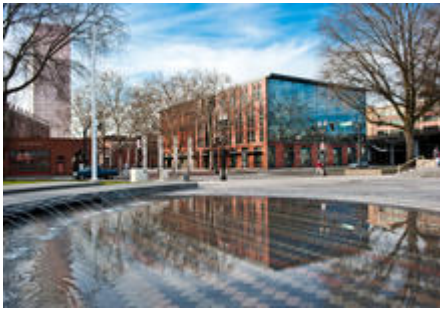
*The building is oriented east-
west - Photo Credit: Jeff
Amram*

The building is oriented east-west, responding to the existing urban grid and allowing for smaller elevations on the east and west, which are difficult to shade. The building took advantage of the existing small openings on the west and southwest sides of the historic building to reduce exposure to the hot afternoon sun.

The long southern elevation is half existing historic punched windows and half new skin using similar glazing percentages. Large trees south of the building provide shade to the building during the warm summer months while allowing beneficial heat gain during the winters. The glazed east elevation permits natural light and beautiful views to the waterfront, while different window opacities limit solar gain.

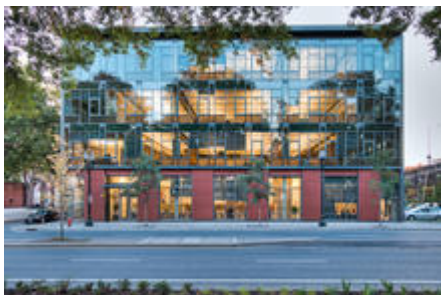
*Ample views and daylight
reach almost every occupant -
Photo Credit: Jeff Amram*

Ample views and daylight reach virtually every work space and increase the indoor environmental quality for the occupants. The furniture is pulled off the windows and uses low, translucent end panels for equitable access to daylight through the space. Efficient lighting design and sensors work with the natural light to reduce overall lighting loads. Individual task lighting also reduces the need for ambient lighting.

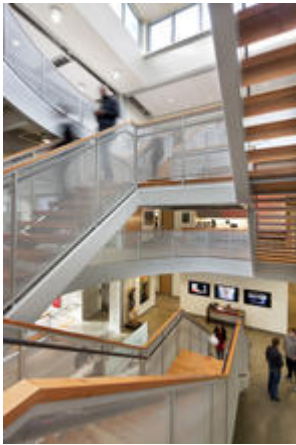
*A central core with a motorized roof monitor above aids in the stack ventilation -
Photo Credit: Lara Swimmer*

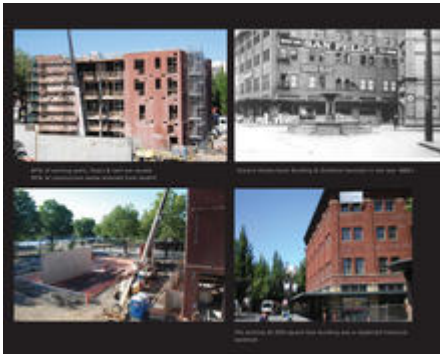
87% of the existing historic Packer-Scott building was re-used. - Photo Credit: THA Architecture

87% of the existing historic Packer-Scott building was re-used. Wood from the existing building was used in finish elements in the new addition in the main stair treads and the reception desk as well as at the coffee bars. During construction, 95% of the waste was diverted from the landfill through recycling or reuse.

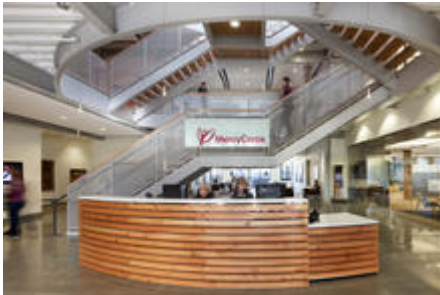
Wood from the existing building was used in finish elements at the reception desk and on the main stair - Photo Credit: Lara Swimmer

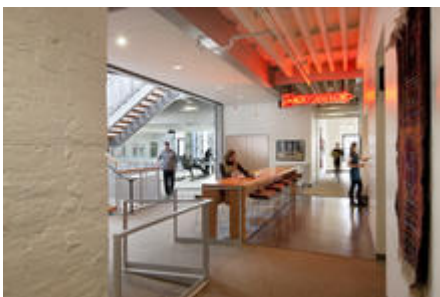
Structural systems were left exposed and minimal finishes applied to save materials - Photo Credit: Lara Swimmer

Structural systems were left exposed and minimal finishes applied to save materials. The raw background is then offset by colorful artwork and artifacts collected from around the world, which inspired the building design, resulting in a simple yet rich environment.
